BATHROOM FIXTURE LOAD TESTING REPORT

CARNIVAL MAGIC

MAY 23RD, 2026

DRY DOCK GBSL, FREEPORT

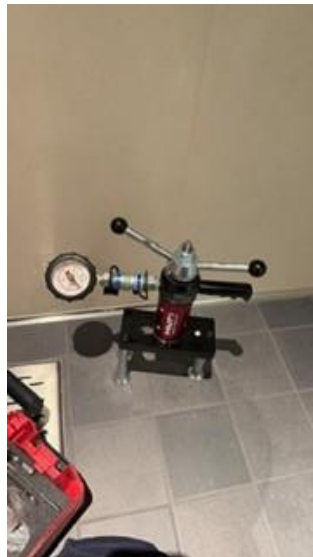
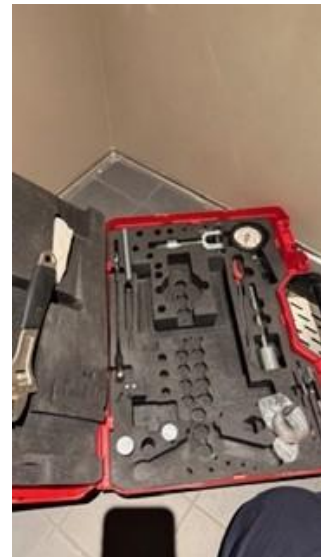
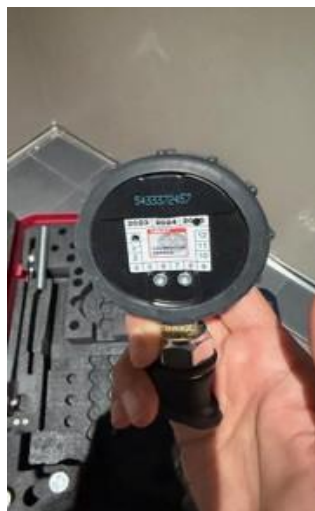
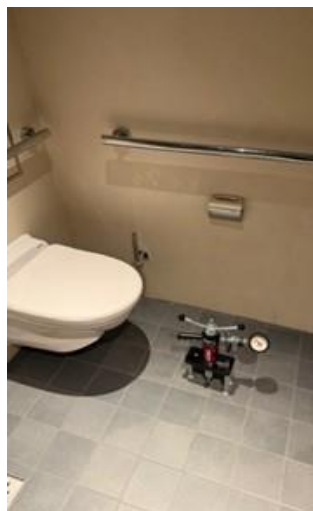
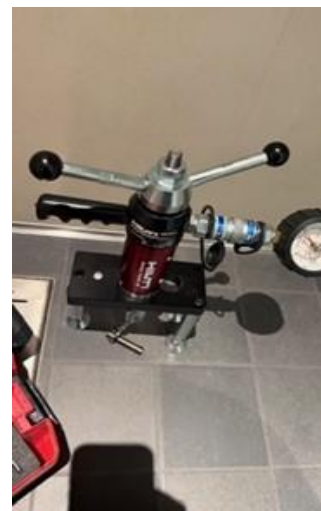
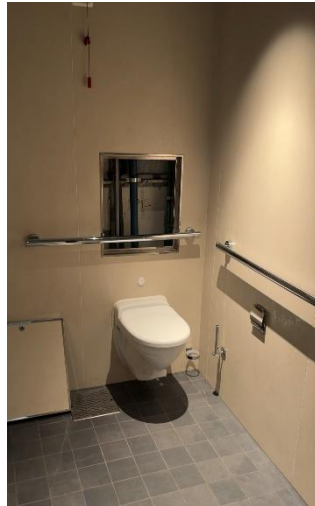
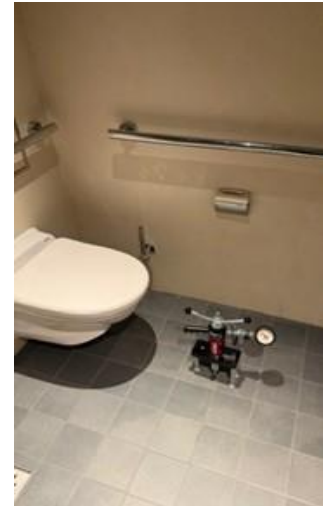
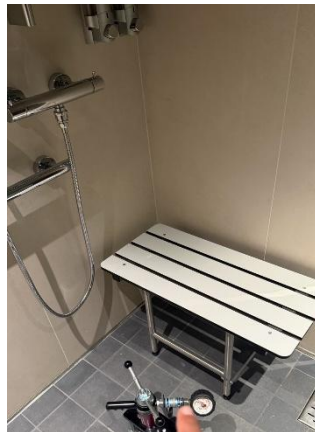
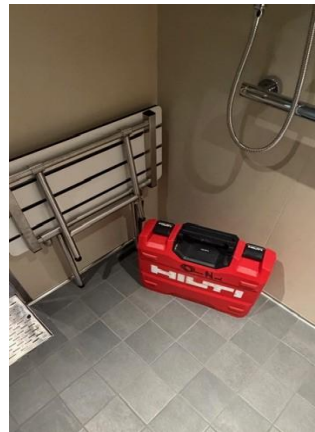
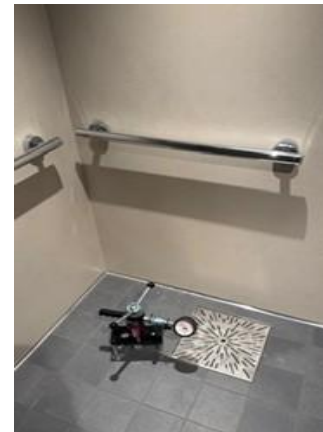
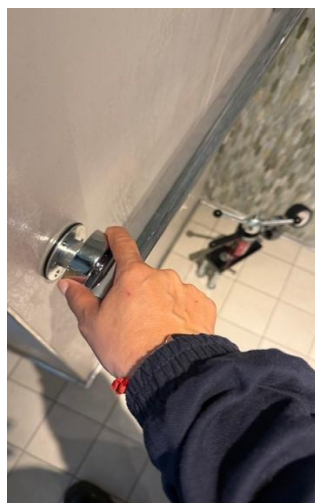
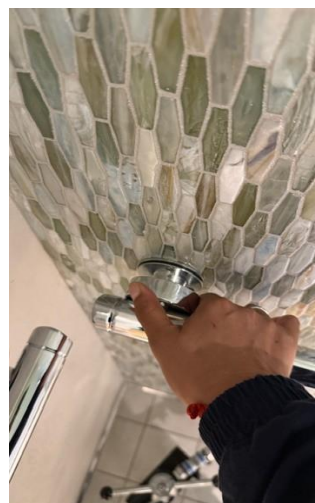
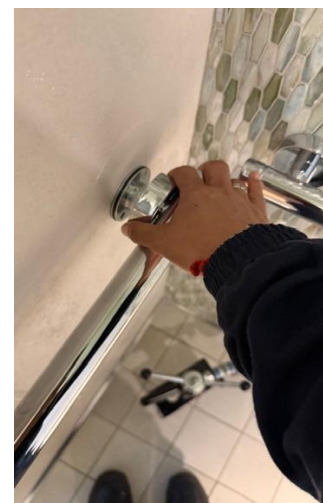
8. PHOTO EVIDENCE

All inspected anchoring points demonstrated **satisfactory performance** under the defined test loads applied using calibrated extraction equipment.

No signs of failure, detachment, or instability were observed at the anchoring interfaces during the application load.

- Anchoring point locations
- Load testing using extractometer
- Equipment identification and gauge readings
- General installation condition
